tuggerah lakes estuary

Restoration of Tuggerah Lakes estuarine system through improved water quality management

Caring for our Country Preliminary Progress Report - \$2M savings from Stage 1

September 2011

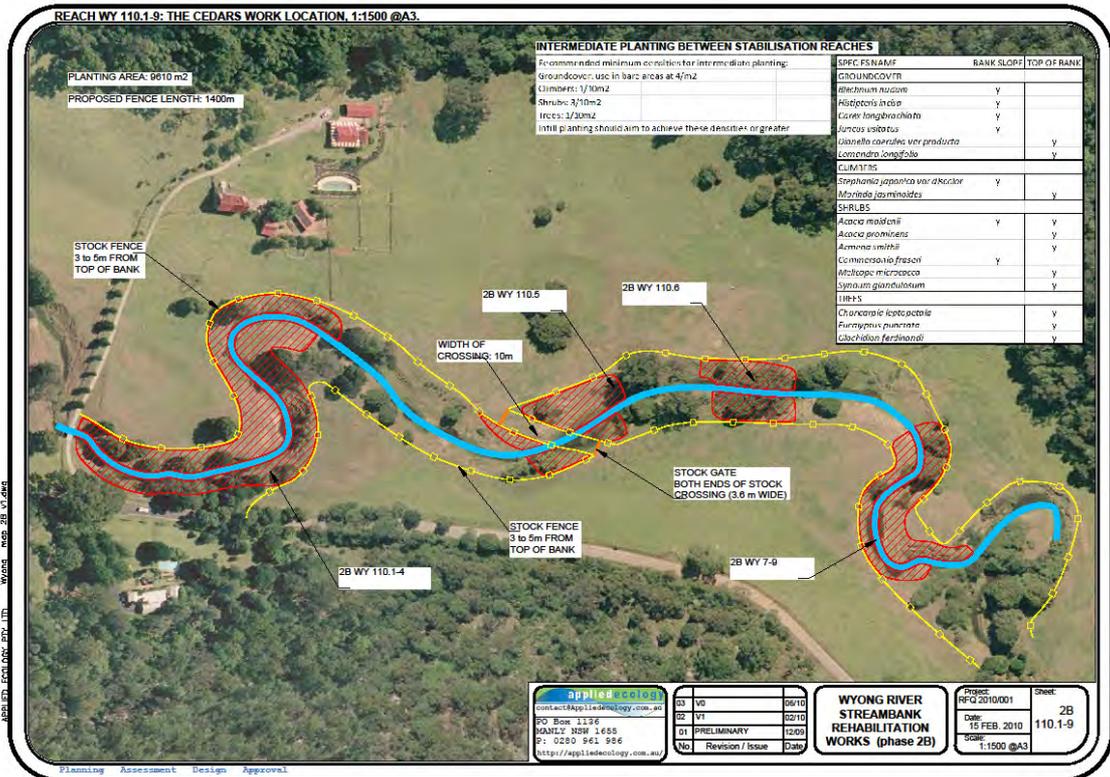
Figure 1: Extent of works – Wyong 110.1-110.9

Works on the property at Reach 110 were commenced in early March 2011 and bank protection works were completed in early June 2011. The works comprised of:

- battering back of vertical embankments at scour locations to achieve a stable profile;
- protection of slopes using jute/coir matting;
- placement of temporary toe protection using coir logs;
- removal of WONS and other environmental weeds; and,
- extensive riparian planting using tube stock of local provenance species.

The works were protected by the installation of 1,400 lineal metres of stock fencing, together with a stabilised controlled cattle crossing.

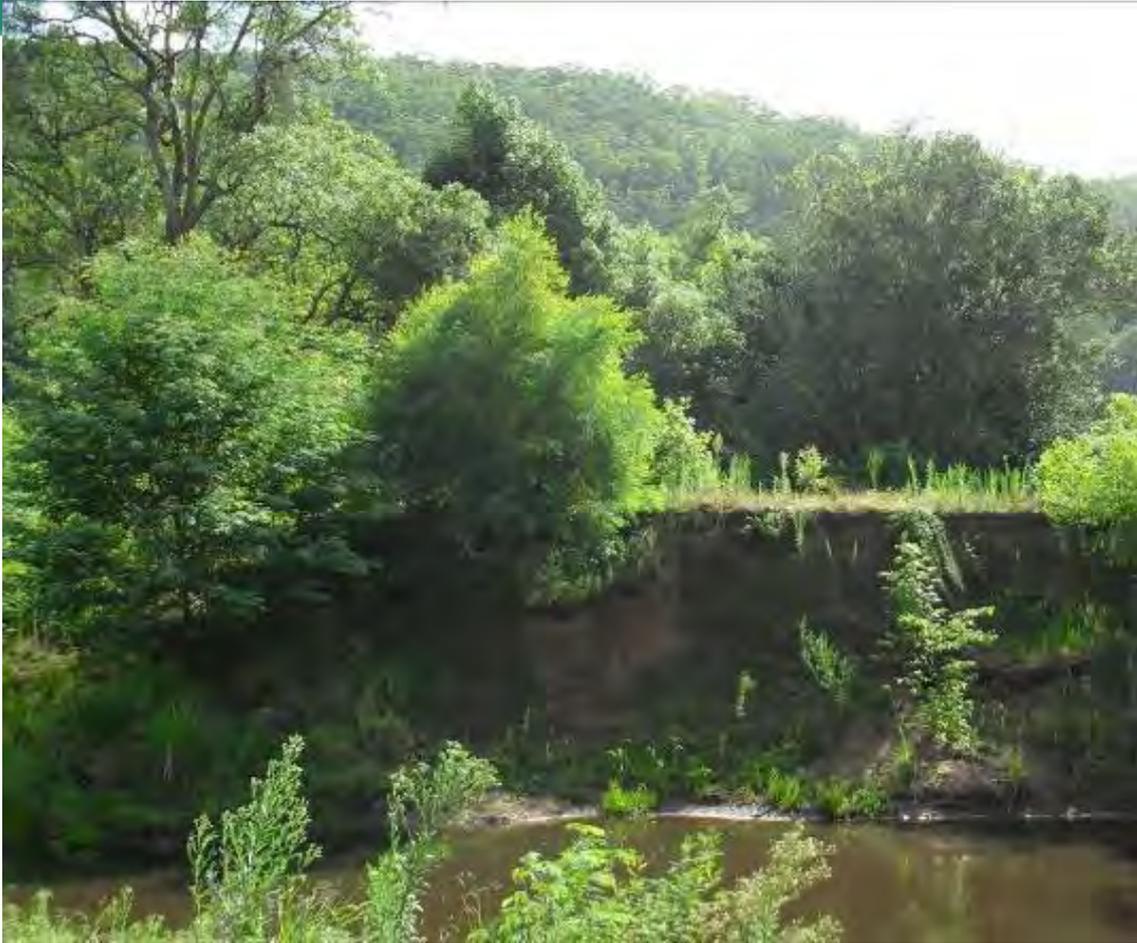
Figure 2: Wyong 110.2 before reprofiling (note vertical embankments)

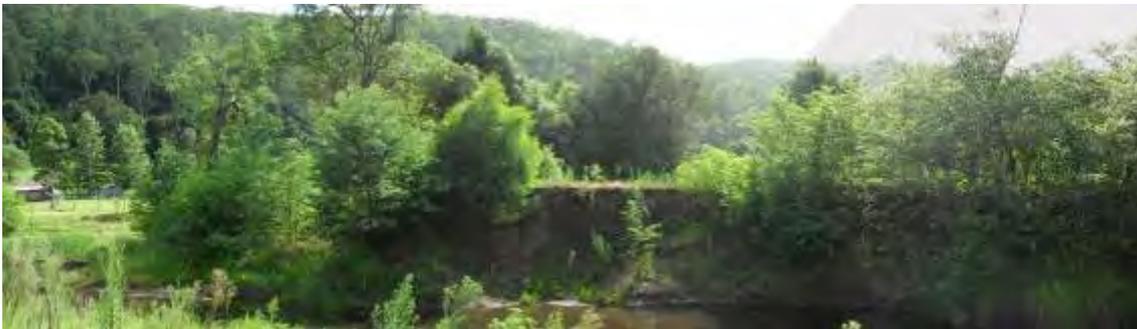
Figure 3: Wyong 110.2 before reprofiling

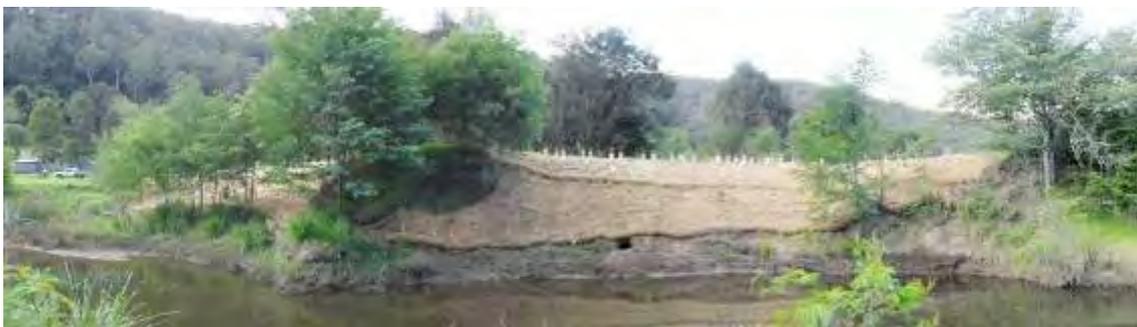
Figure 4: Wyong 110.2 after reprofiling and planting

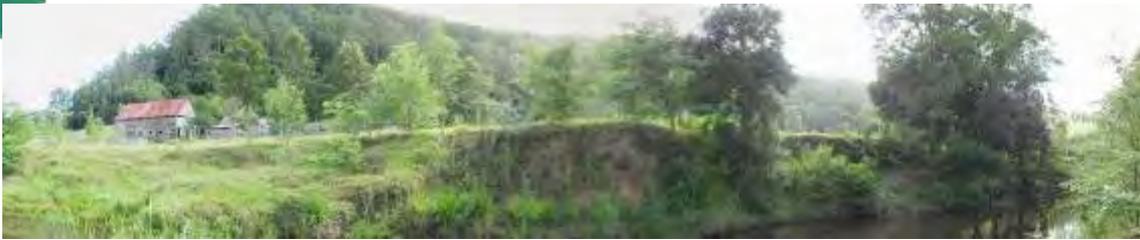
Figure 5: Wyong 110.4 before reprofiling

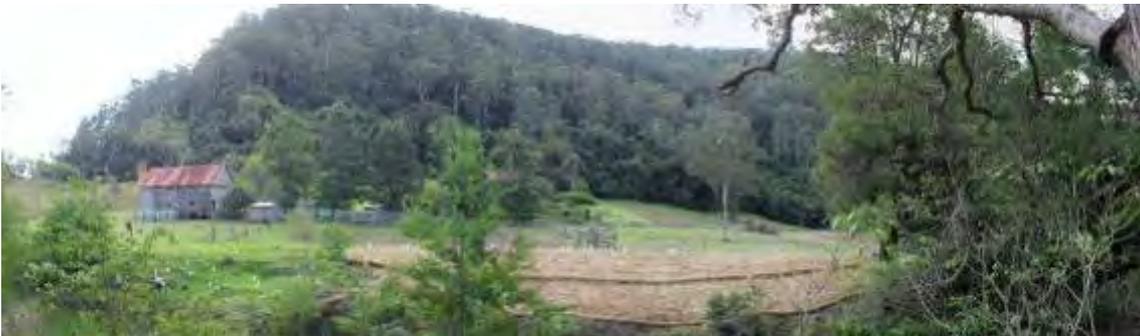
Figure 6: Wyong 110.4 after reprofiling and planting

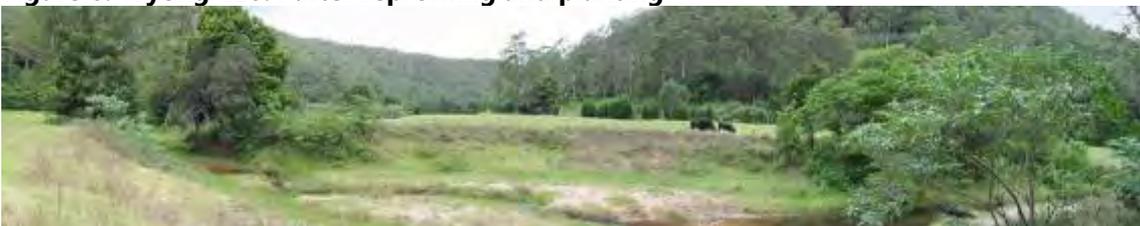
Figure 7: Wyong 110.5 prior to construction of cattle crossing area and reprofiling

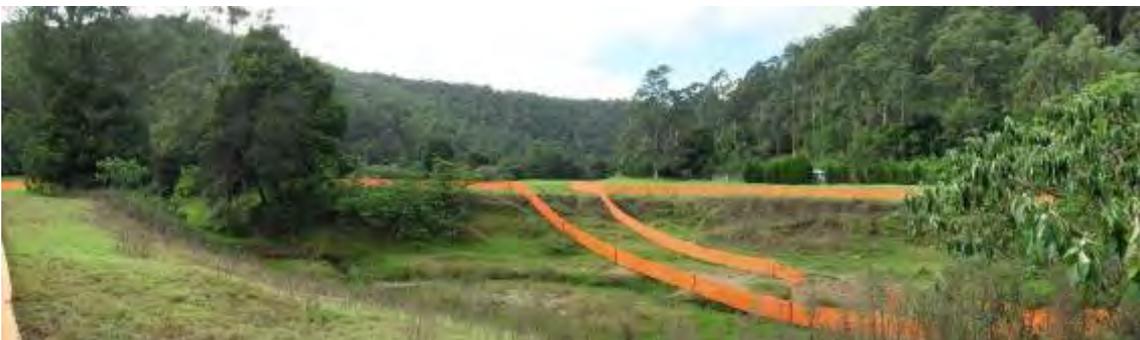
Figure 8: Wyong 110.5 prior to construction of cattle crossing area and reprofiling

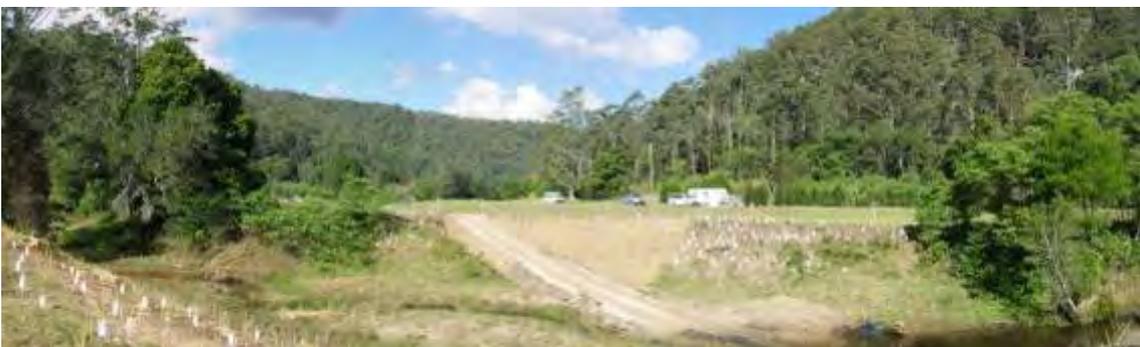
Figure 9: Wyong 110.5 after reprofiling, planting and construction of cattle crossing

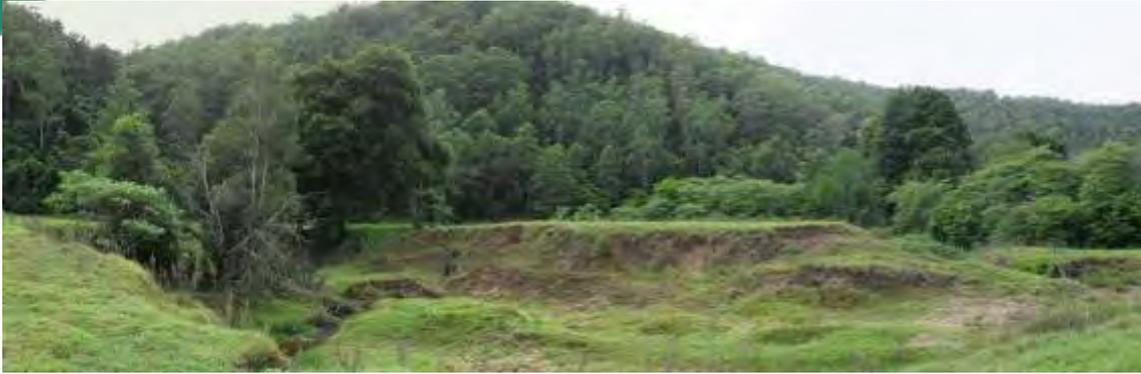
Figure 10: Wyong 110.9 prior to planting

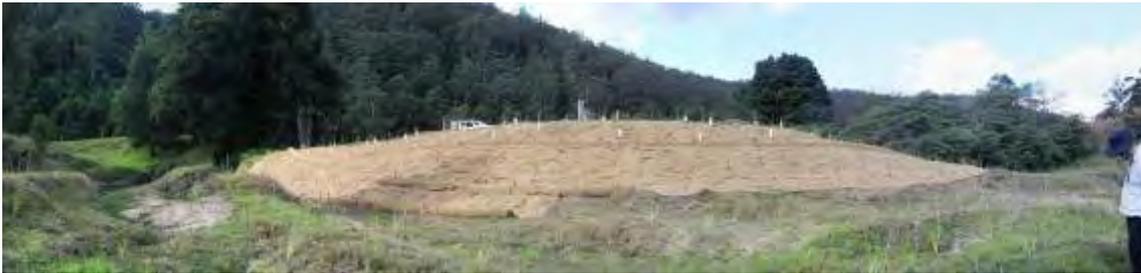
Figure 11: : Wyong 110.9 after planting

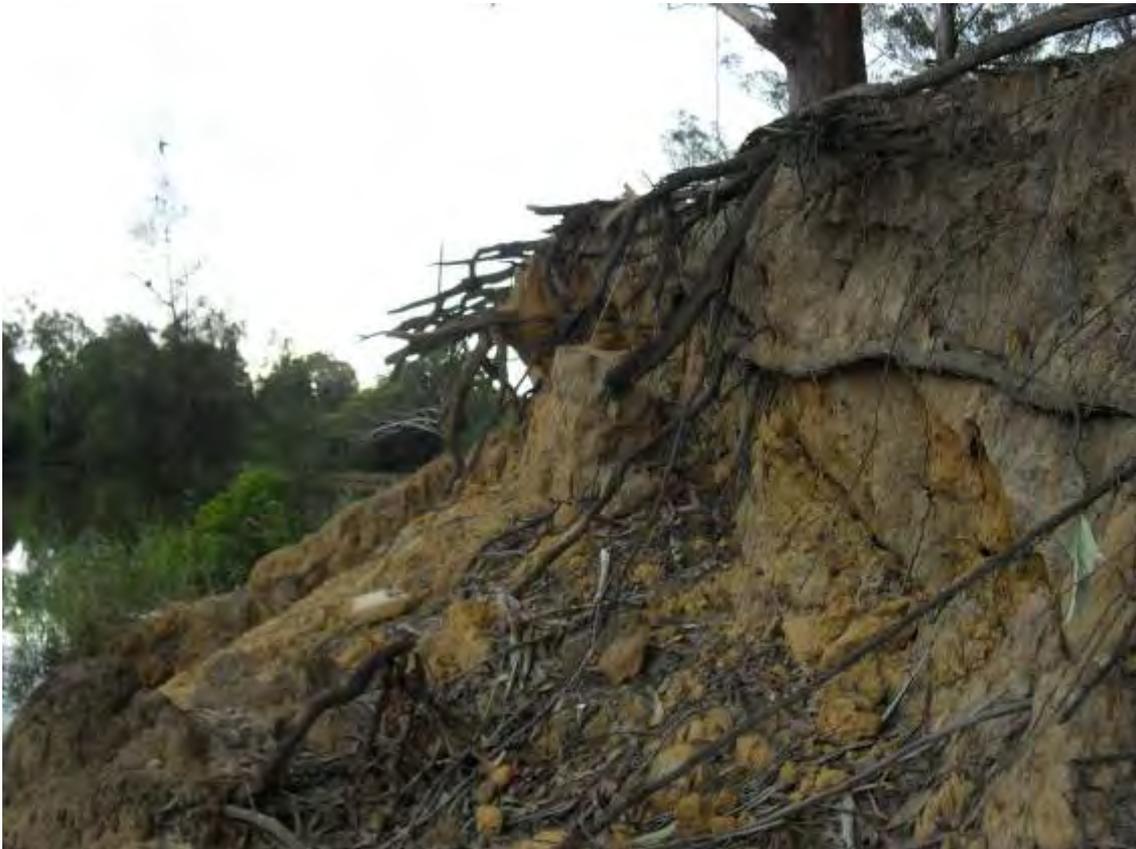
Reach 44 is located on the northern side of Ourimbah creek just upstream of Lees Bridge. Scour in this location had left an exposed vertical embankment of approximately 150 metres in length with unstable trees located on the edge of the embankment. The tree roots had lost much of their supporting soil and significantly overhang the embankment. In lower velocity areas some vegetation had re-established in the slumped material deposited around the toe of the embankment. In the higher velocity areas around the outside of the bend, the scour plane was continuing to encroach further into the reserve as sediment continued to be removed from the slope.

Figure 12: Slope prior to reprofiling, note vertical face and undercutting below tree roots

The works in this location involved removing 6 mature trees from the embankment overhang, together with one immature tree located in the batter area. The slope was reprofiled to between 1-in-2 and 1-in-3 batter to minimise impact on the trees to be retained in the riparian zone. The removed trees with root balls intact were placed at the toe of the embankment to provide for toe protection at the base of the slope. These trees were secured using hardwood piles extending approximately 700mm higher than the top of the woody debris to prevent remobilisation of the debris during flood events.

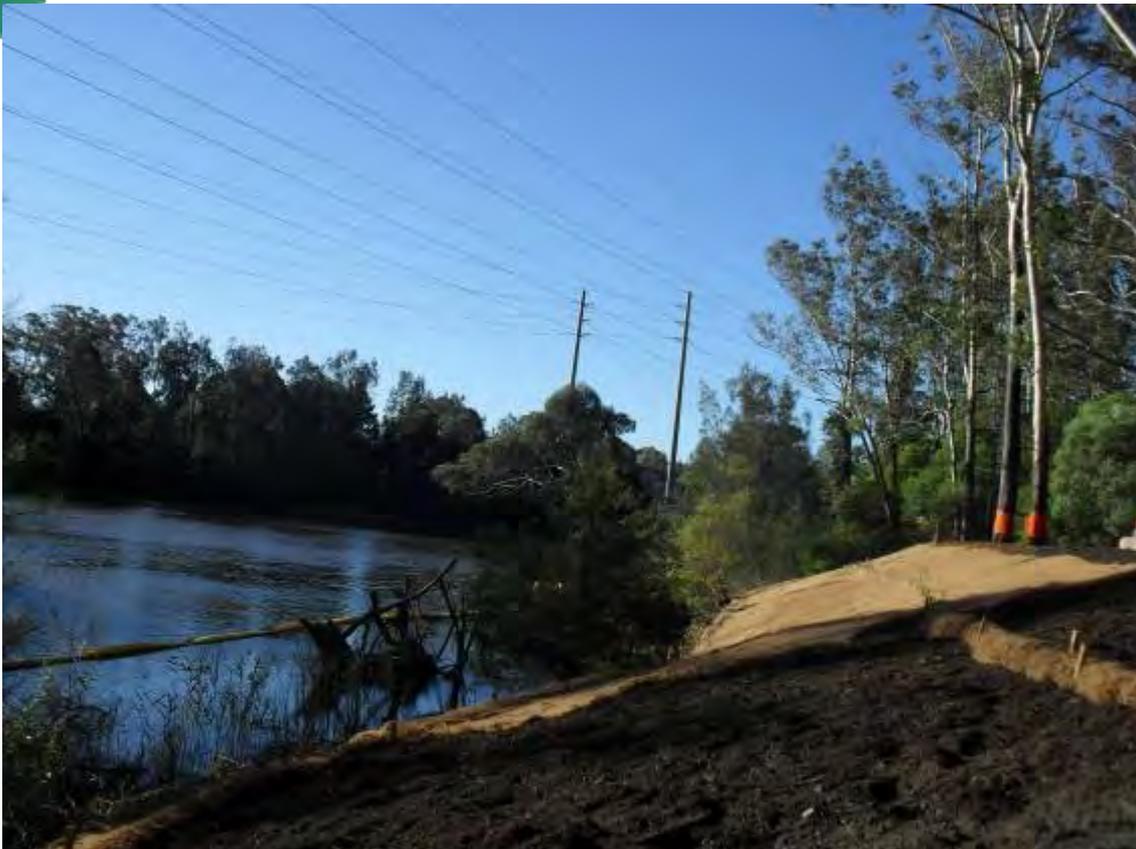
Figure 13: Slope after reprofiling and during placement of coir matting for soil protection

The batter slope was of low fertility and water holding ability, therefore soil amelioration was carried out prior to stabilisation with coir logs and coir matting. Soil amelioration used organic soil mix to a depth of approximately 100mm together with organic mulch. Both were placed under the coir matting.

The coir matting provides temporary soil stabilisation against erosive forces from wind and raindrop impact on the exposed soil surface as well as minor flood flows. Approximately 1,500m² of riparian area was revegetated using provenance tube stock in early August.

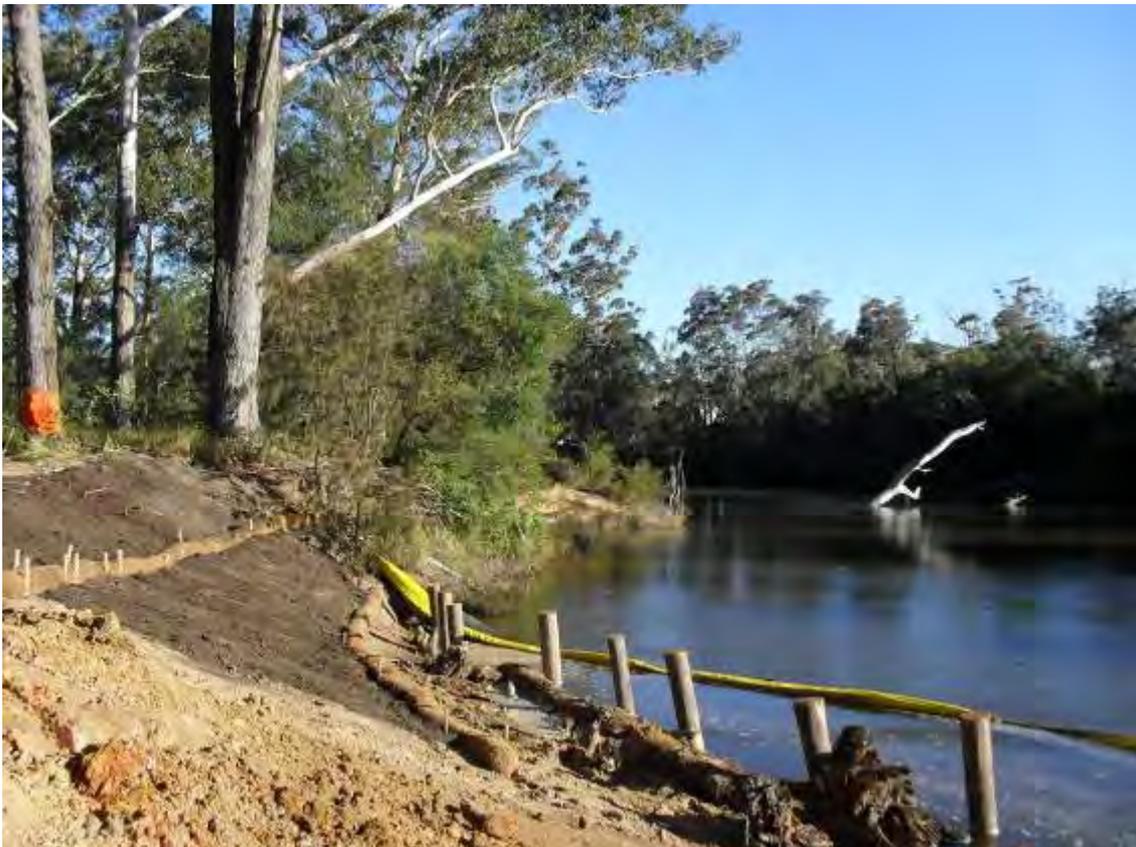
Figure 14: Placement of piles and large woody debris for toe protection

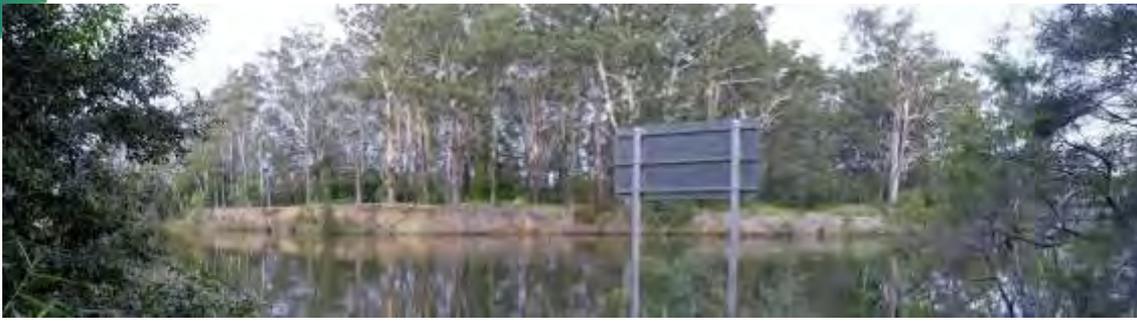
Figure 15: Reach 44 as seen from opposite bank prior to rehabilitation. Photo taken from submarine cable crossing point on south bank.

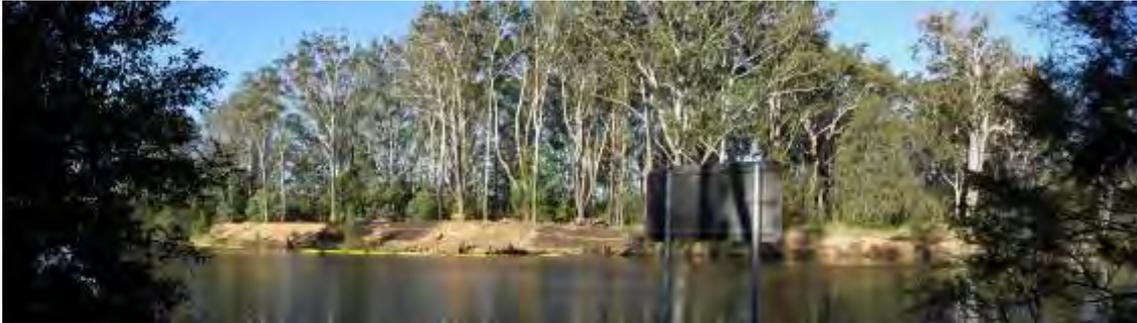
Figure 16: Reach 44 as seen from opposite bank after reprofiling, toe protection and during coir matting placement. Photo taken from submarine cable crossing point on south bank.

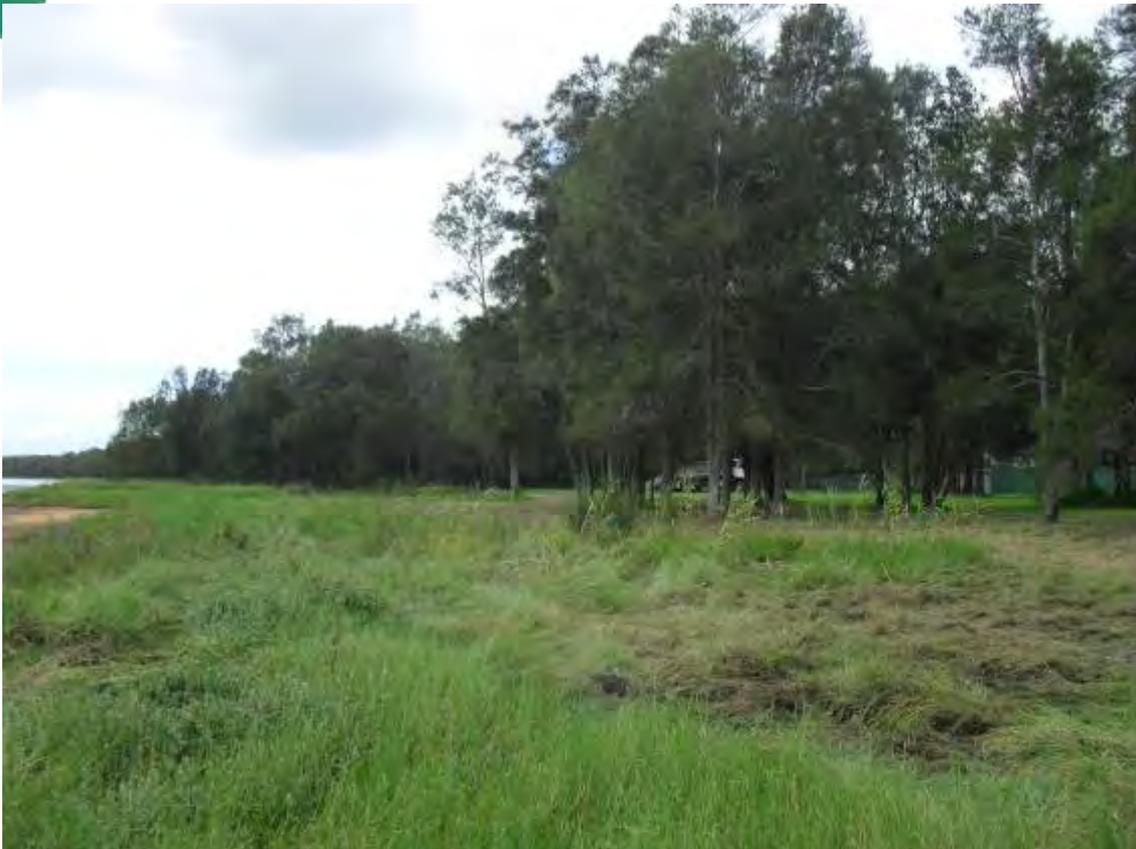
Figure 17: TL 20 prior to rehabilitation works

These sites required reprofiling to achieve a 1% grade from RL0.2 AHD to RL0.4 AHD. This grade established a slope suitable for periodic inundation (for saltmarsh plant growth) and seagrass wrack assimilation. The soil removed from these sites was determined to be acid sulphate soil which required treatment on site using lime, prior to disposal to landfill.

In addition, the remaining soil was found to be an unworkable saturated material which was not suitable for achieving the required profile or for planting out with saltmarsh. This soil was previously dredged material used to establish a reclaimed shoreline during the Tuggerah Lakes Restoration Program in the 1990's. As a result of this, sandy loam topsoil was imported to provide a suitable media for planting into and grading to the desired profile.

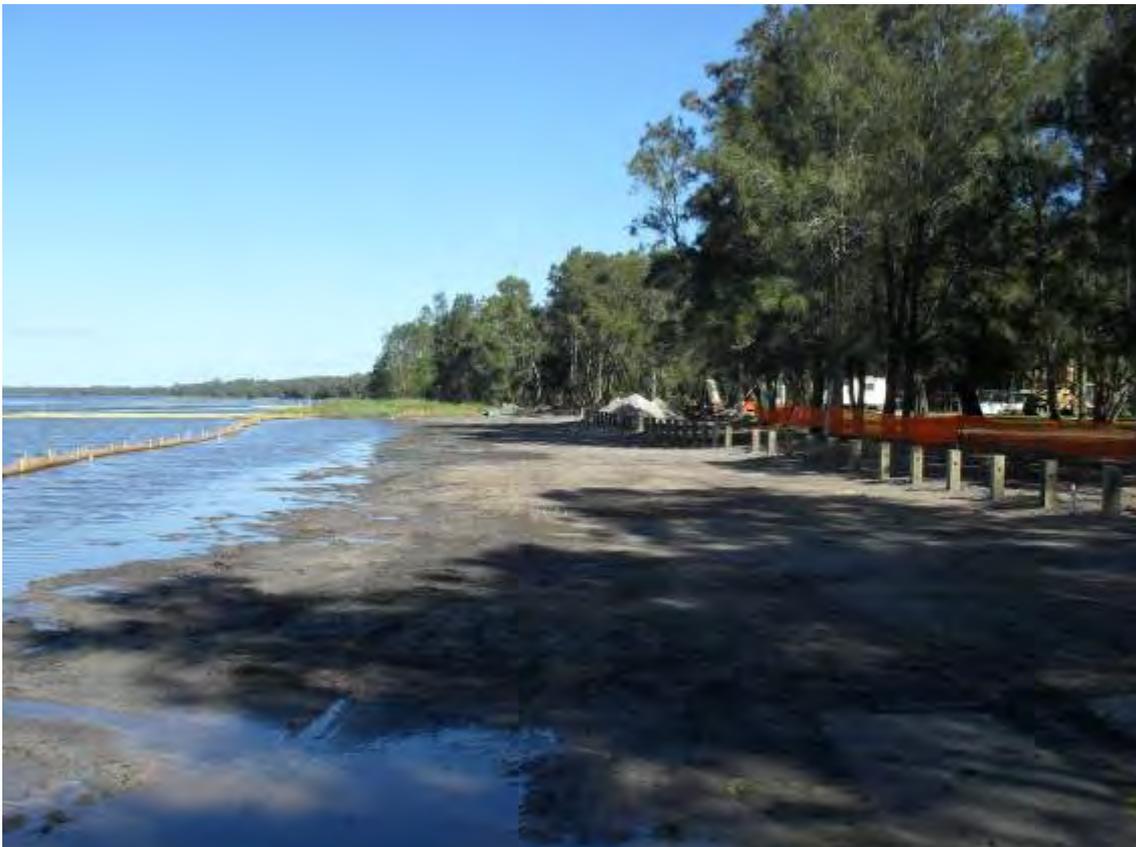
Figure 18: TL 20 after reprofiling

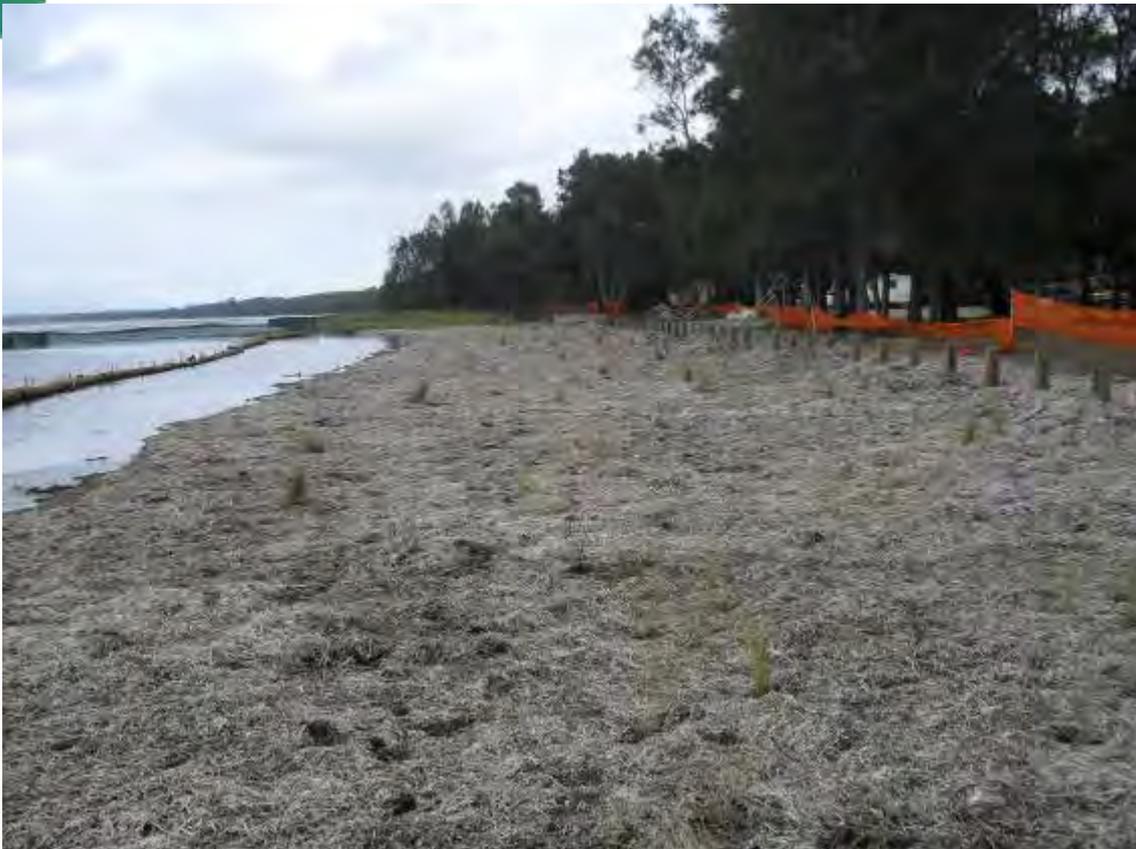
Figure 19: TL 20 after planting and wrack placement

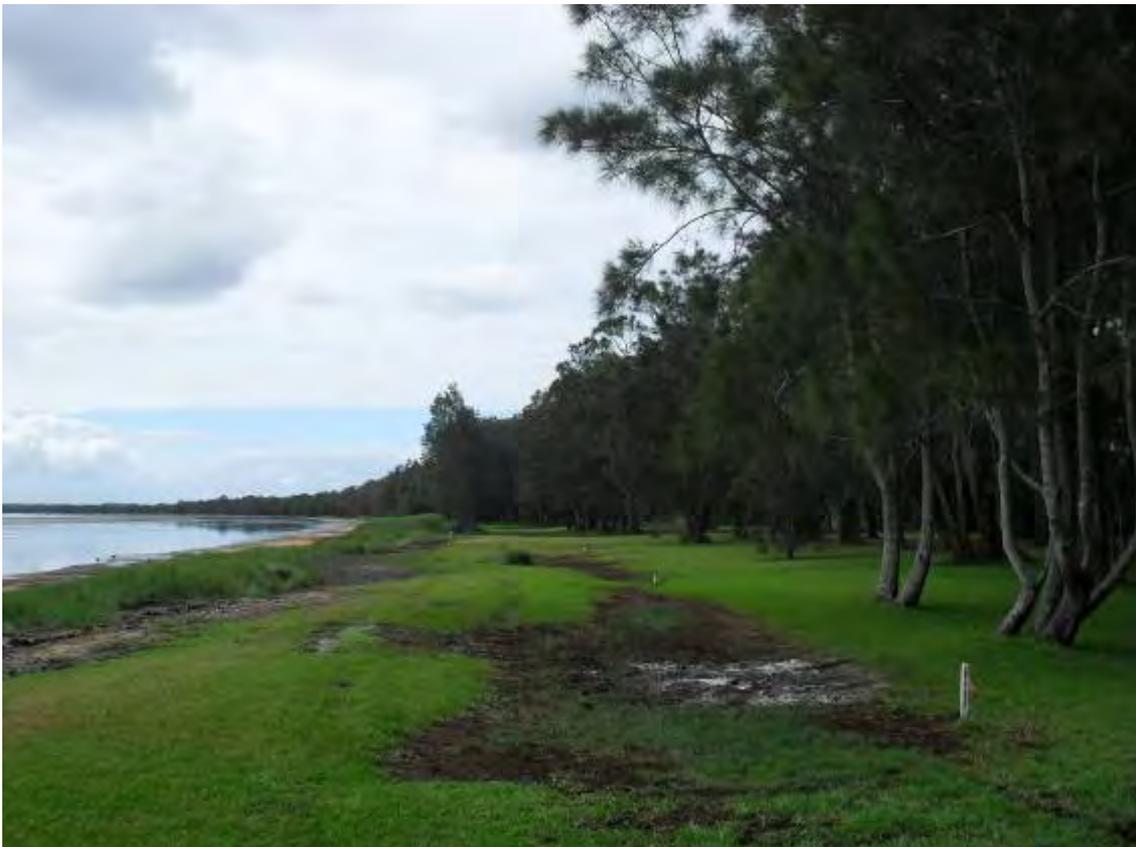
Figure 20: TL 19 prior to rehabilitation

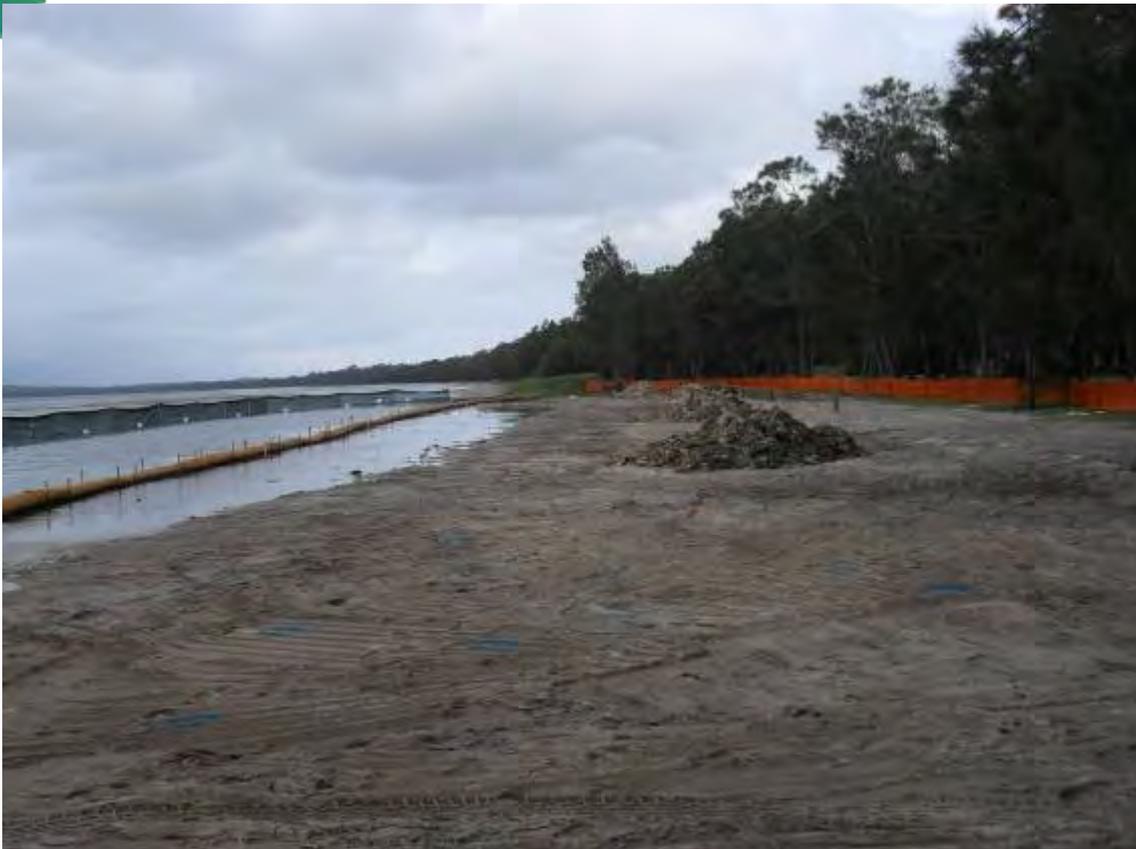
Figure 21: TL 19 after reprofiling

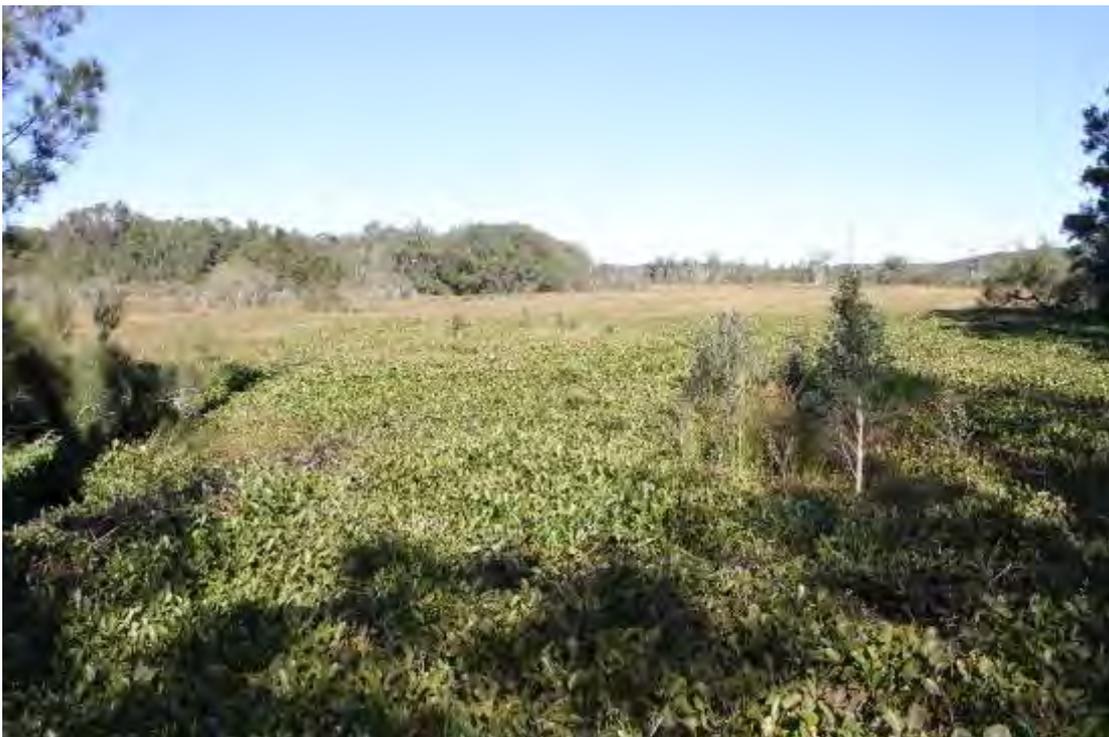
The aim of this project was to improve the integrity and function of a key SEPP14 wetland that had become choked with Water Hyacinth (*Eichhornia crassipes*). The removal of this weed from the wetland has resulted in a system that has a higher ecological and habitat value and is more stable in nature.

Figure 22: Tuggerah Lagoon – Water hyacinth infestation prior to works commencing

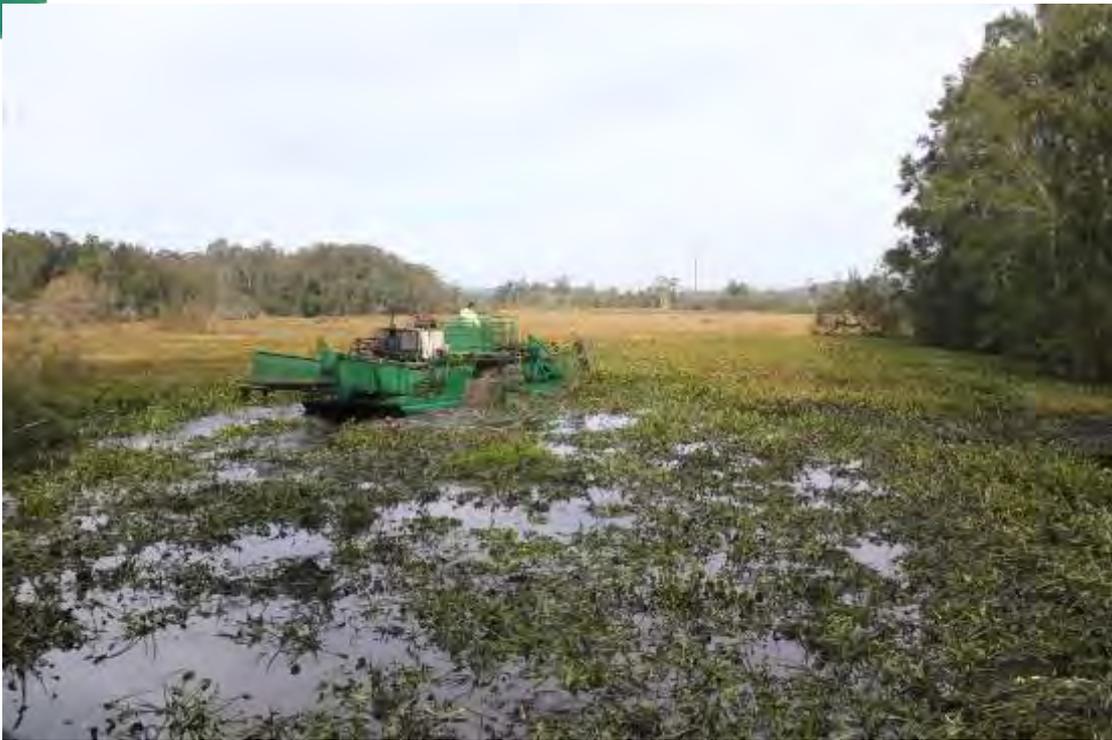
Figure 23: Tuggerah Lagoon –removal of water hyacinth with the truxor

This project was undertaken by NSW National Parks and Wildlife Services, who engaged a contractor to undertake the initial weed removal. A truxor was used to remove the Water Hyacinth infestation from the 5.5ha wetland with supplementary spraying of Long-leaf Willow Primrose (*Ludwigia longifolia*) undertaken in the early stages of the project. Maintenance of the wetland will be continued by both the contractor and NPWS.

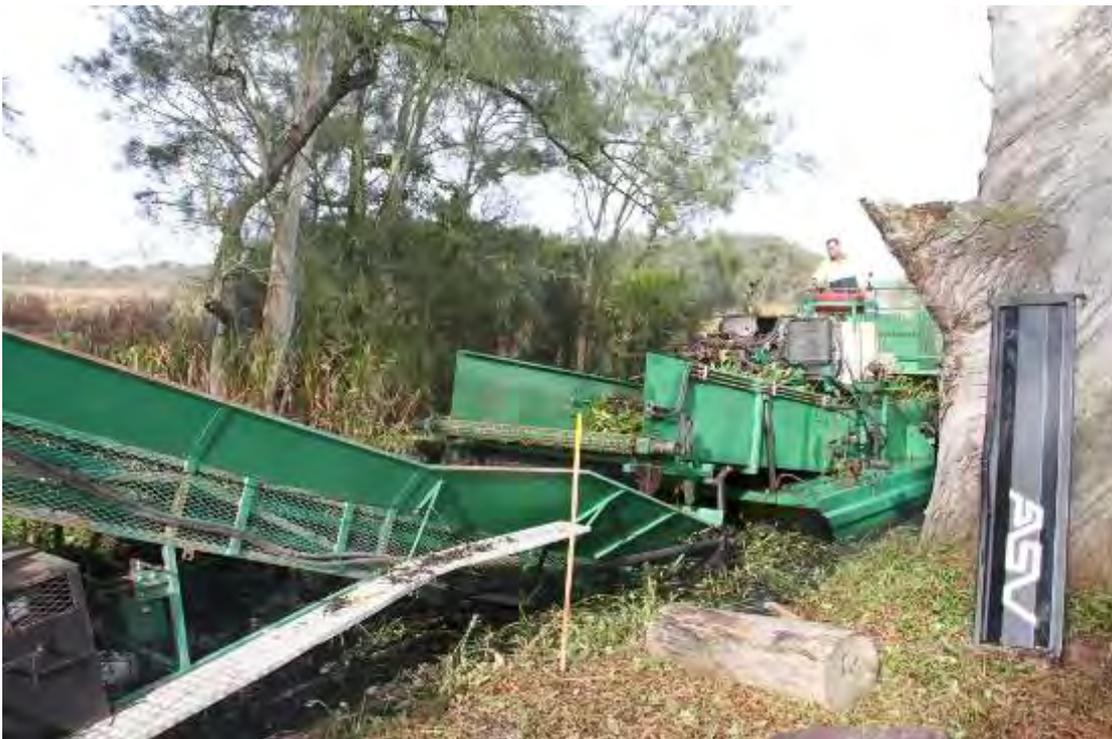
Figure 24: Weed removal machinery on Tuggerah Lagoon
